Investigation of Steel-Stringer Bridges: Superstructures and Substructures, Volume II

Final Report
October 2007

Sponsored by
the Iowa Highway Research Board (Project TR-522)
and the Iowa Department of Transportation (CTRE Project 04-184).

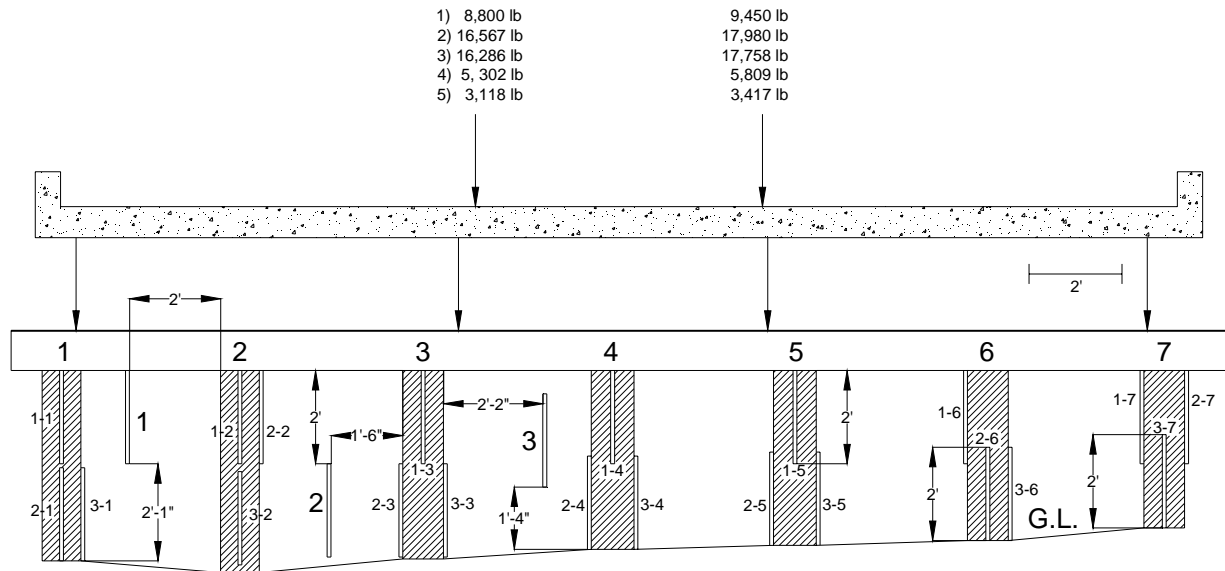
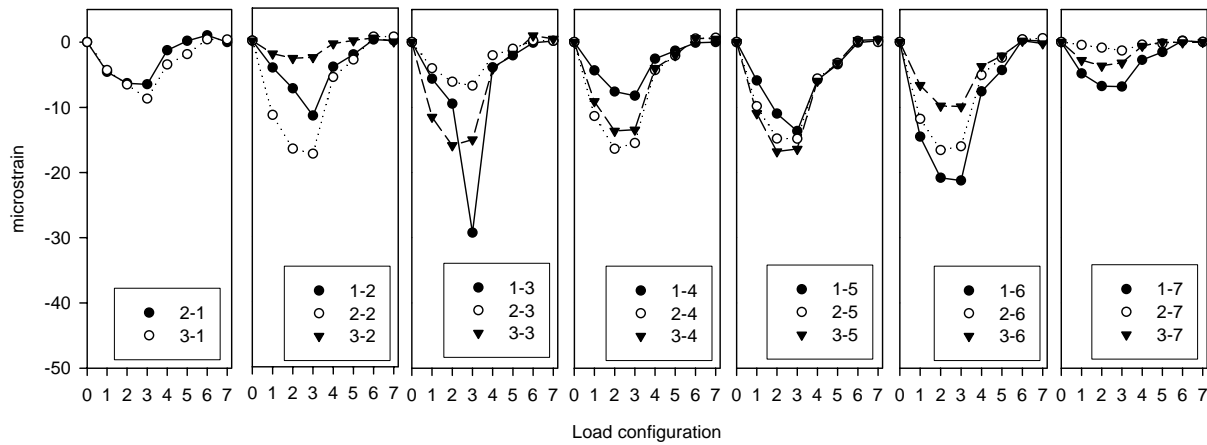
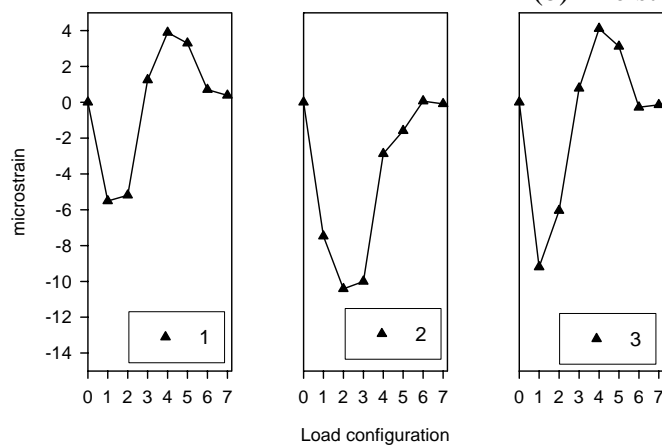
Figure 12.24. Static load test at the centerline of the west abutment (Bridge No. 029070 – Humboldt County)

Loading the west abutment at the centerline of the bridge resulted in high strain values in pile nos. 2, 3, 5, and 6. It appears that the load was more uniformly distributed while loading along the centerline of the bridge deck. The highest strain noted, which was about -29 microstrains, was in pile no. 2 in load configuration 3 (see Figure 12.24). The backwall strains changed from negative to positive with increasing load configuration.

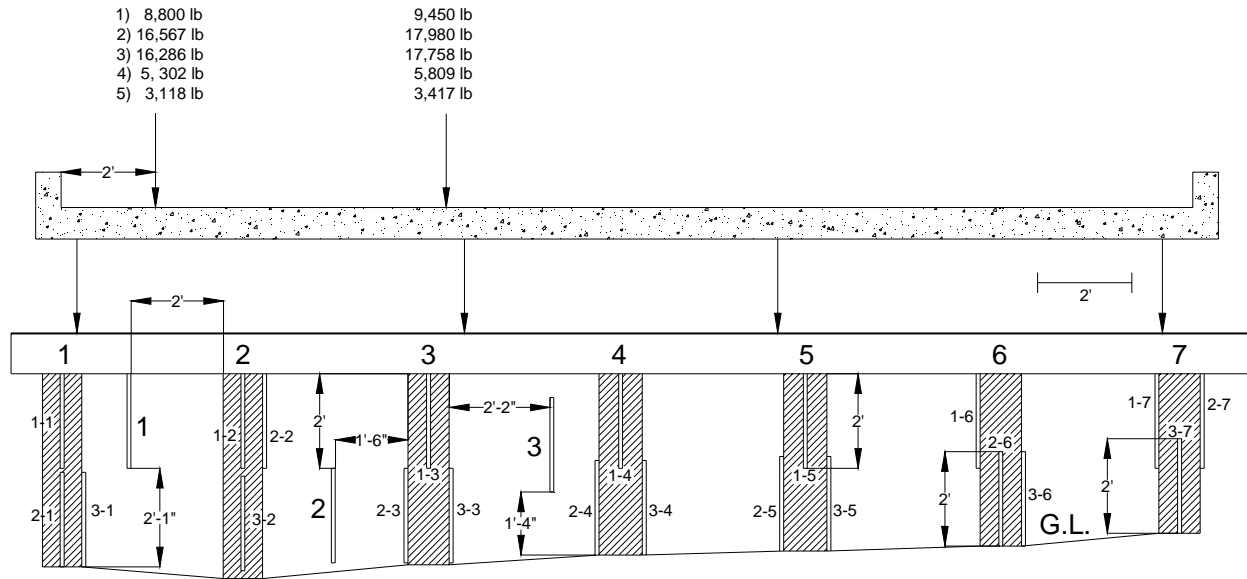
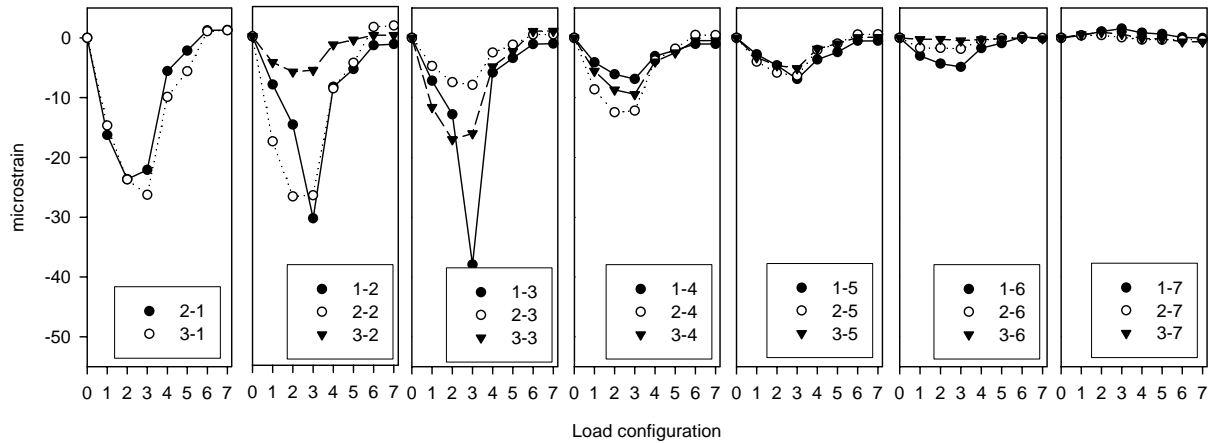
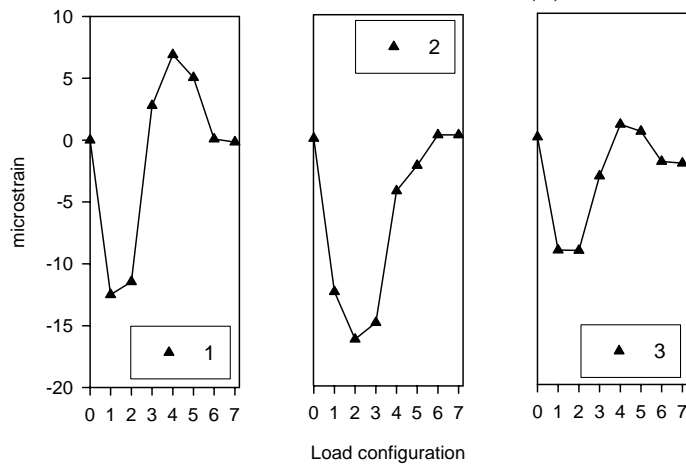
Figure 12.25. Static load test at the south edge of the west abutment (Bridge No. 029070 – Humboldt County)

The last load test under taken at the west abutment was completed with the loading at the south edge of the bridge. The location of the axial loads, which were offset 2 ft from the curb, the pile strain measurements, and the backwall strain are shown in Figure 12.25. Similar to the north edge test, the strain was highest directly under the axial load (pile nos. 1, 2, and 3) and decreased with increasing distance from the location of the load. The highest strain measured, which was about -38 microstrains, was in pile No. 3 in load configuration 3. The backwall strains continued to change from negative to positive as shown in Figure 12.25c.

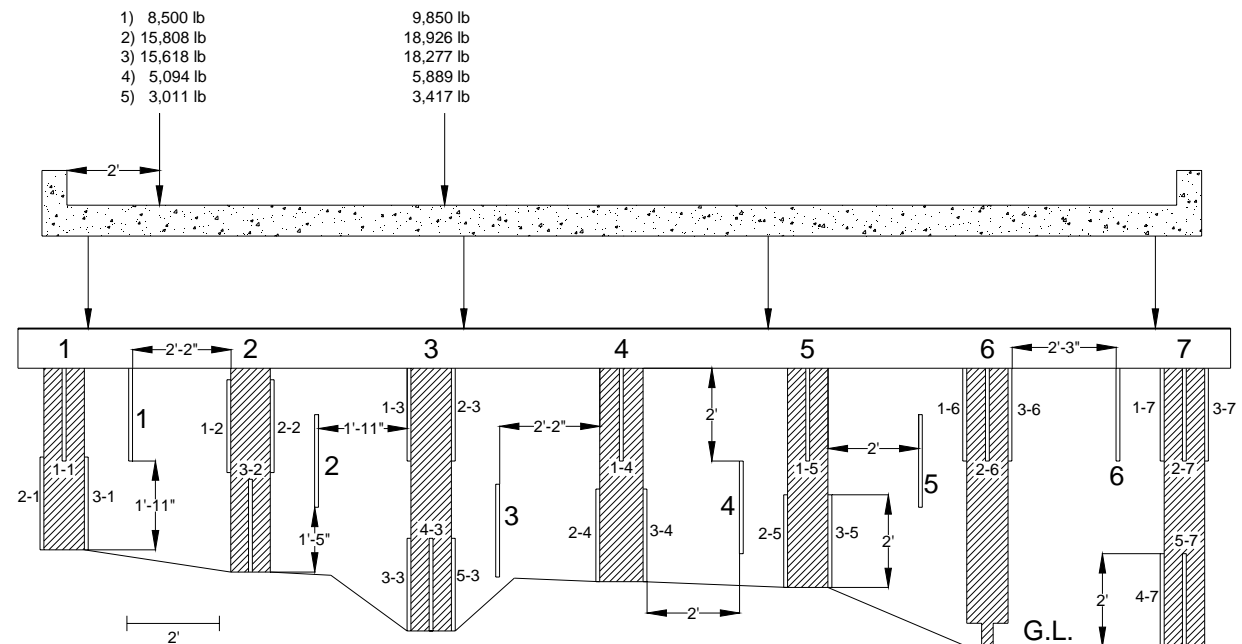
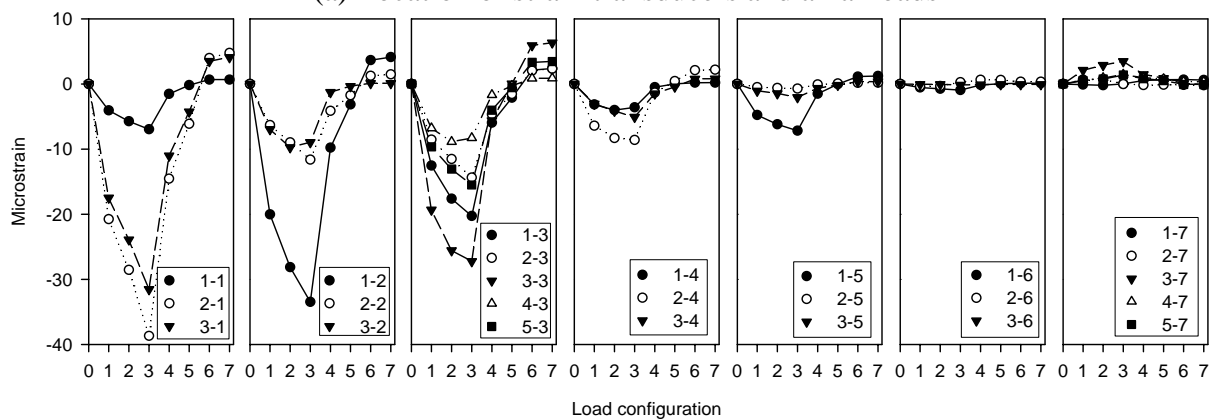
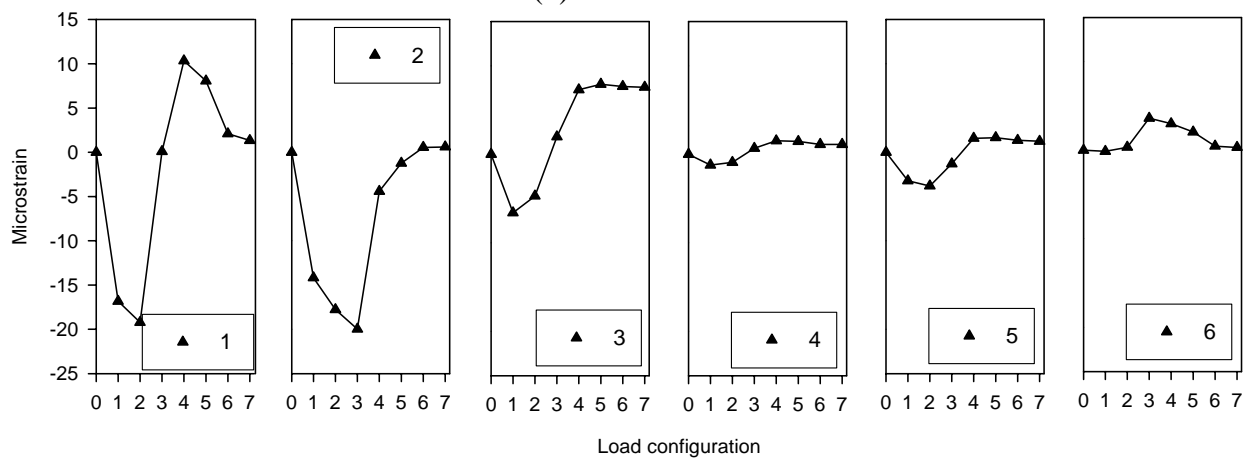
Figure 12.26. Static load test at the north edge of the east abutment (Bridge No. 029070 – Humboldt County)

The east abutment was first loaded at the north edge (See Figure 12.26a). Pile nos. 1, 2, and 3, which were directly under the axial loads, experienced the highest strains (See Figure 12.26b). The highest strain, which was about -39 microstrains in pile no. 1, was in load configuration 3. At higher load configurations, the pile strains were reduced because some of the loads were being transferred to the west abutment. The strains also decreased in piles away from the location of the applied loads. The backwall was in compression in load configurations 1 through 4. The backwall strains at higher load configurations were either zero or positive (See Figure 12.26c).

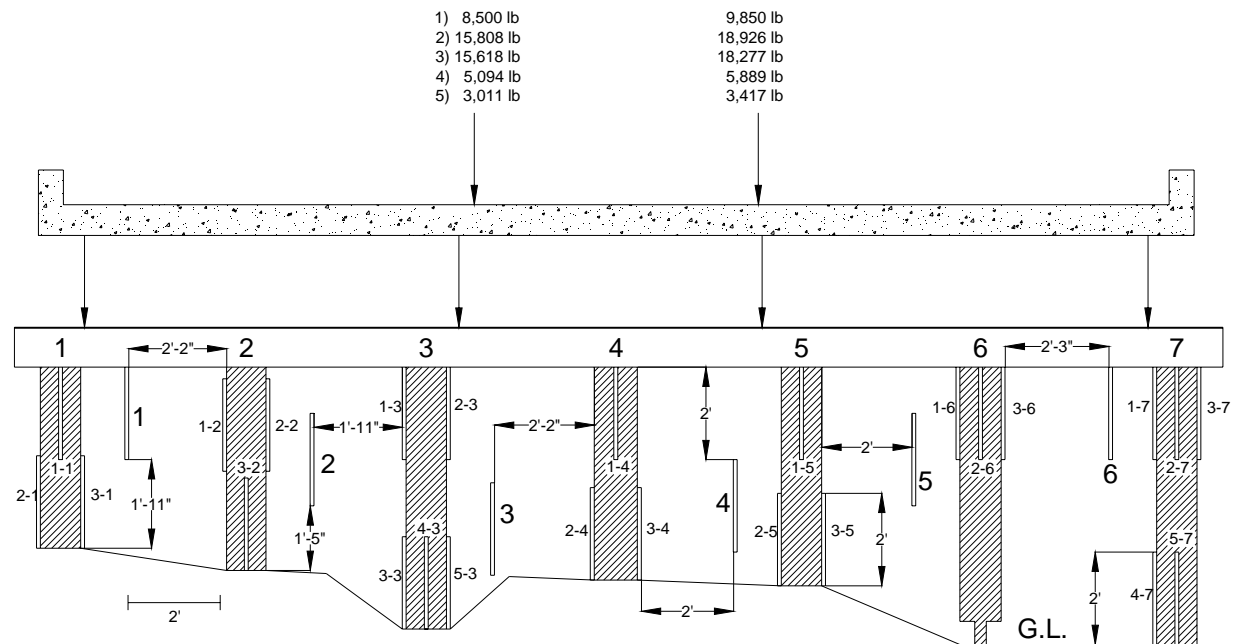
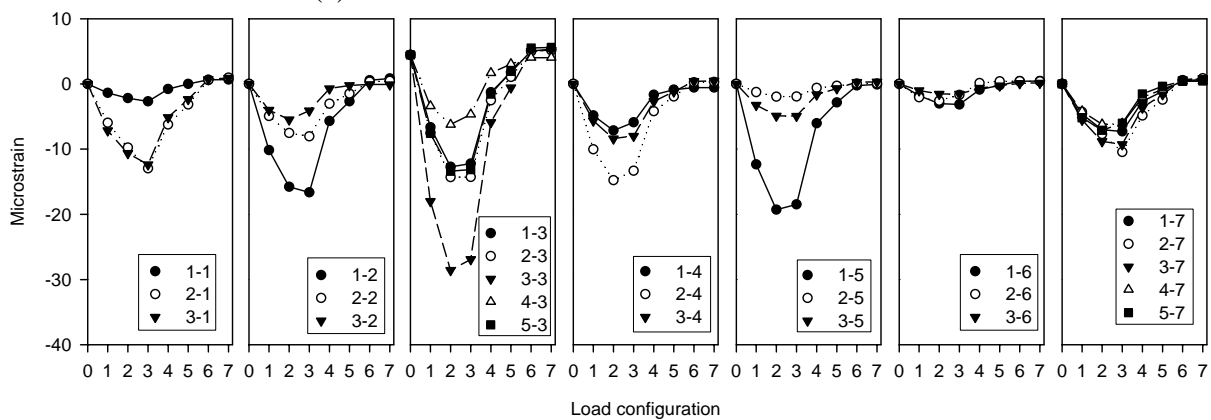
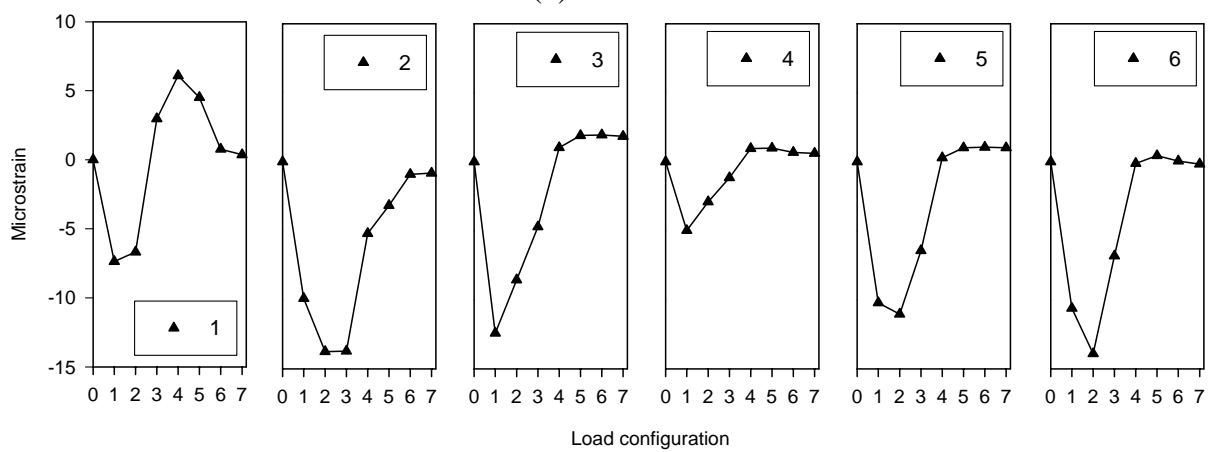
Figure 12.27. Static load test at the centerline of the east abutment (Bridge No. 029070 – Humboldt County)

The location of the applied loads at the centerline of the east abutment, pile strain measurements, and backwall strains are shown in Figure 12.27. The results demonstrate that the load was mainly transferred to pile nos. 3 and 5, which were directly under the axial loads. The highest strain measured was in pile no. 3 and was about -30 microstrains. Moving the load to the centerline of the bridge deck resulted in about 30% reduction in the backwall strains between pile nos. 1 and 2, 2 and 3, and 3 and 4. At the south edge of the bridge (between pile nos. 4 and 7) the backwall strains increased by approximately a factor of 4.

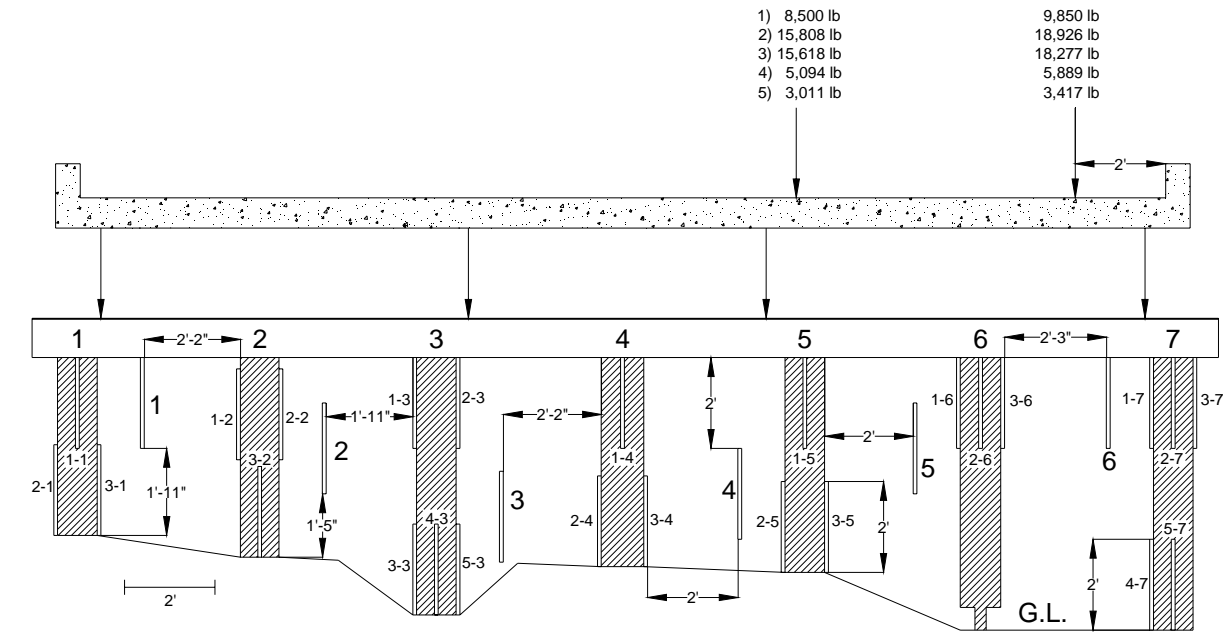
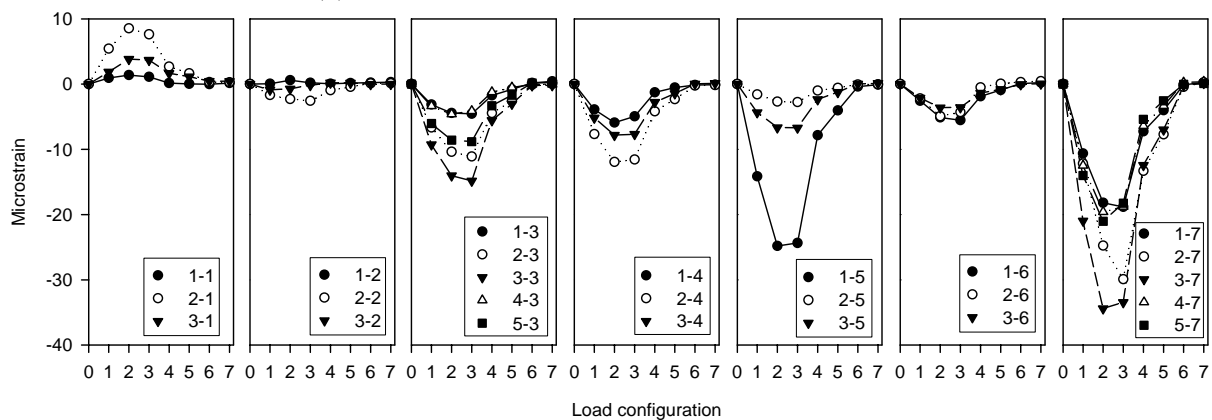
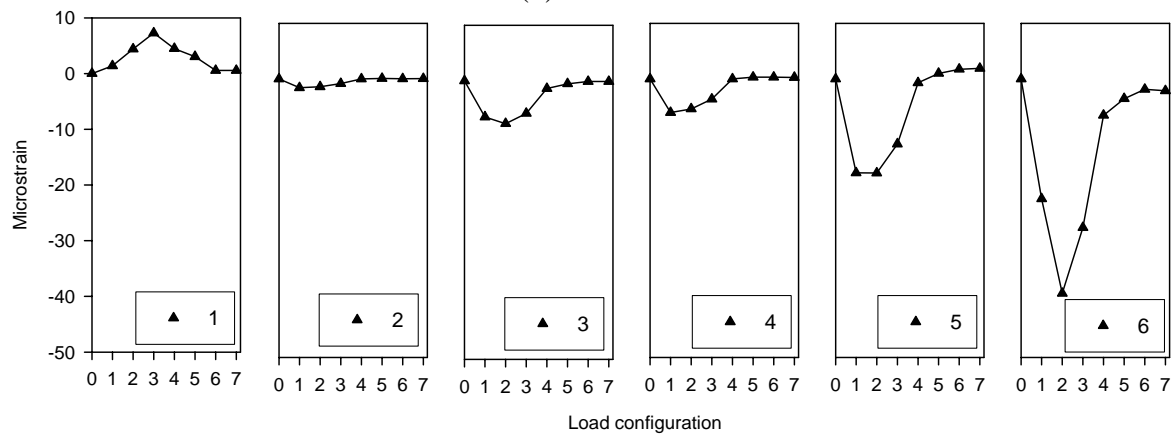
Figure 12.28. Static load test at the south edge of the east abutment (Bridge No. 029070 – Humboldt County)

The third test was completed with the applied load at the south edge. The location of the applied loads, pile strain measurements, and backwall strains are presented in Figure 12.28. Similar to previous tests, the load was concentrated under the location of the applied loads. Pile no. 7 experienced the highest strain, which was about -34 microstrains in load configuration 2. The load decreased with increasing distance from the location of axial loads. Pile no. 6, which had a diameter of about 3 inches near the ground level, experienced small strains. Strains measured in pile no. 1 were positive, which may be due to pile bending caused by loading the bridge at the north edge.

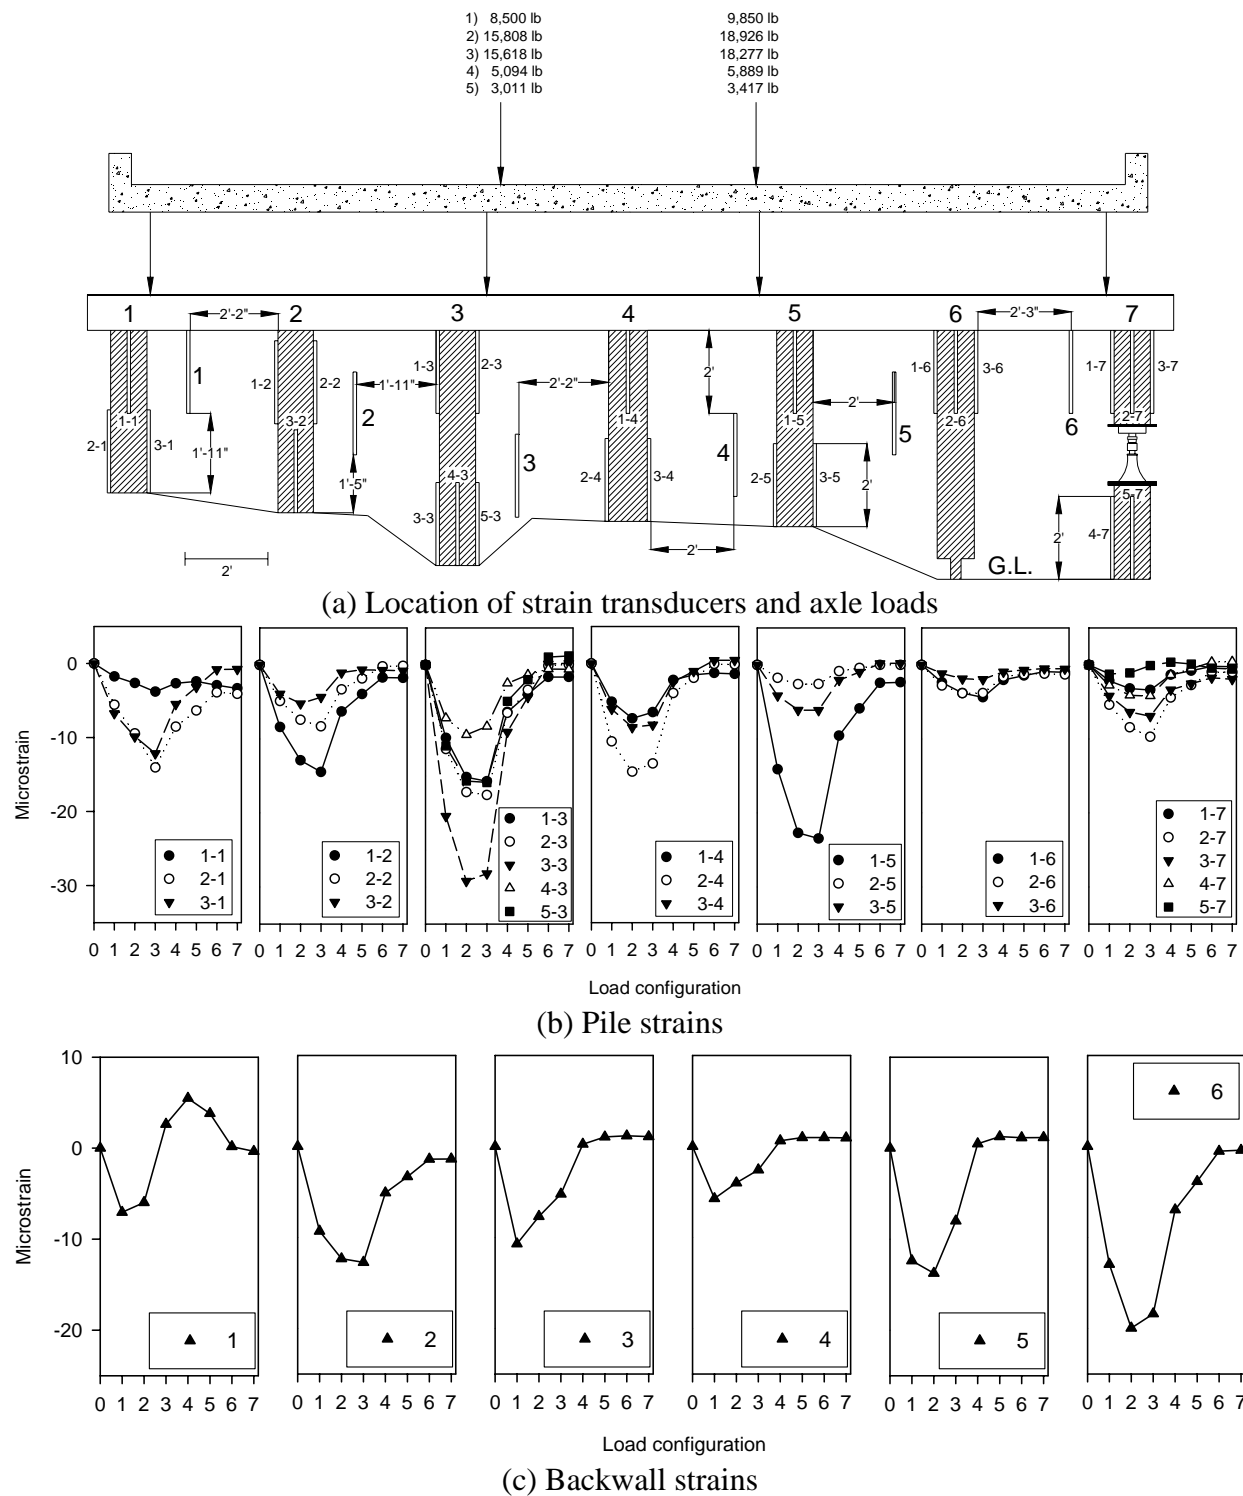
Figure 12.29. Static load test at the centerline with pile No. 7 jacked (Bridge No. 029070 – Humboldt County)

The first destructive test at the east abutment was carried out by removing a section out of pile No. 7 and replacing it with a mechanical jack and load cell as shown in Figure 12.29a. Load was applied through the mechanical jack to restore the pile initial strain measurement. Two tests were conducted: one with the loading at the centerline and one with the loading at the south edge of the bridge deck.

The results of loading the east abutment along the centerline of the bridge deck are shown in Figure 12.29. The strain data were essentially the same strain data obtained in the nondestructive load test at the centerline that was previously conducted (Refer to Figure 12.27). This indicates that the procedure of jacking pile no. 7 was successful in restoring the abutment initial loading condition. Using the load cell, the load carried by pile no. 7 (minus the dead load) was recorded and the stresses in the pile were determined. The stresses varied laterally and longitudinally through the pile section illustrating the non-homogeneity of wood. The results also demonstrate that the load carried by pile no. 7 was about 8% of the total applied axial load.

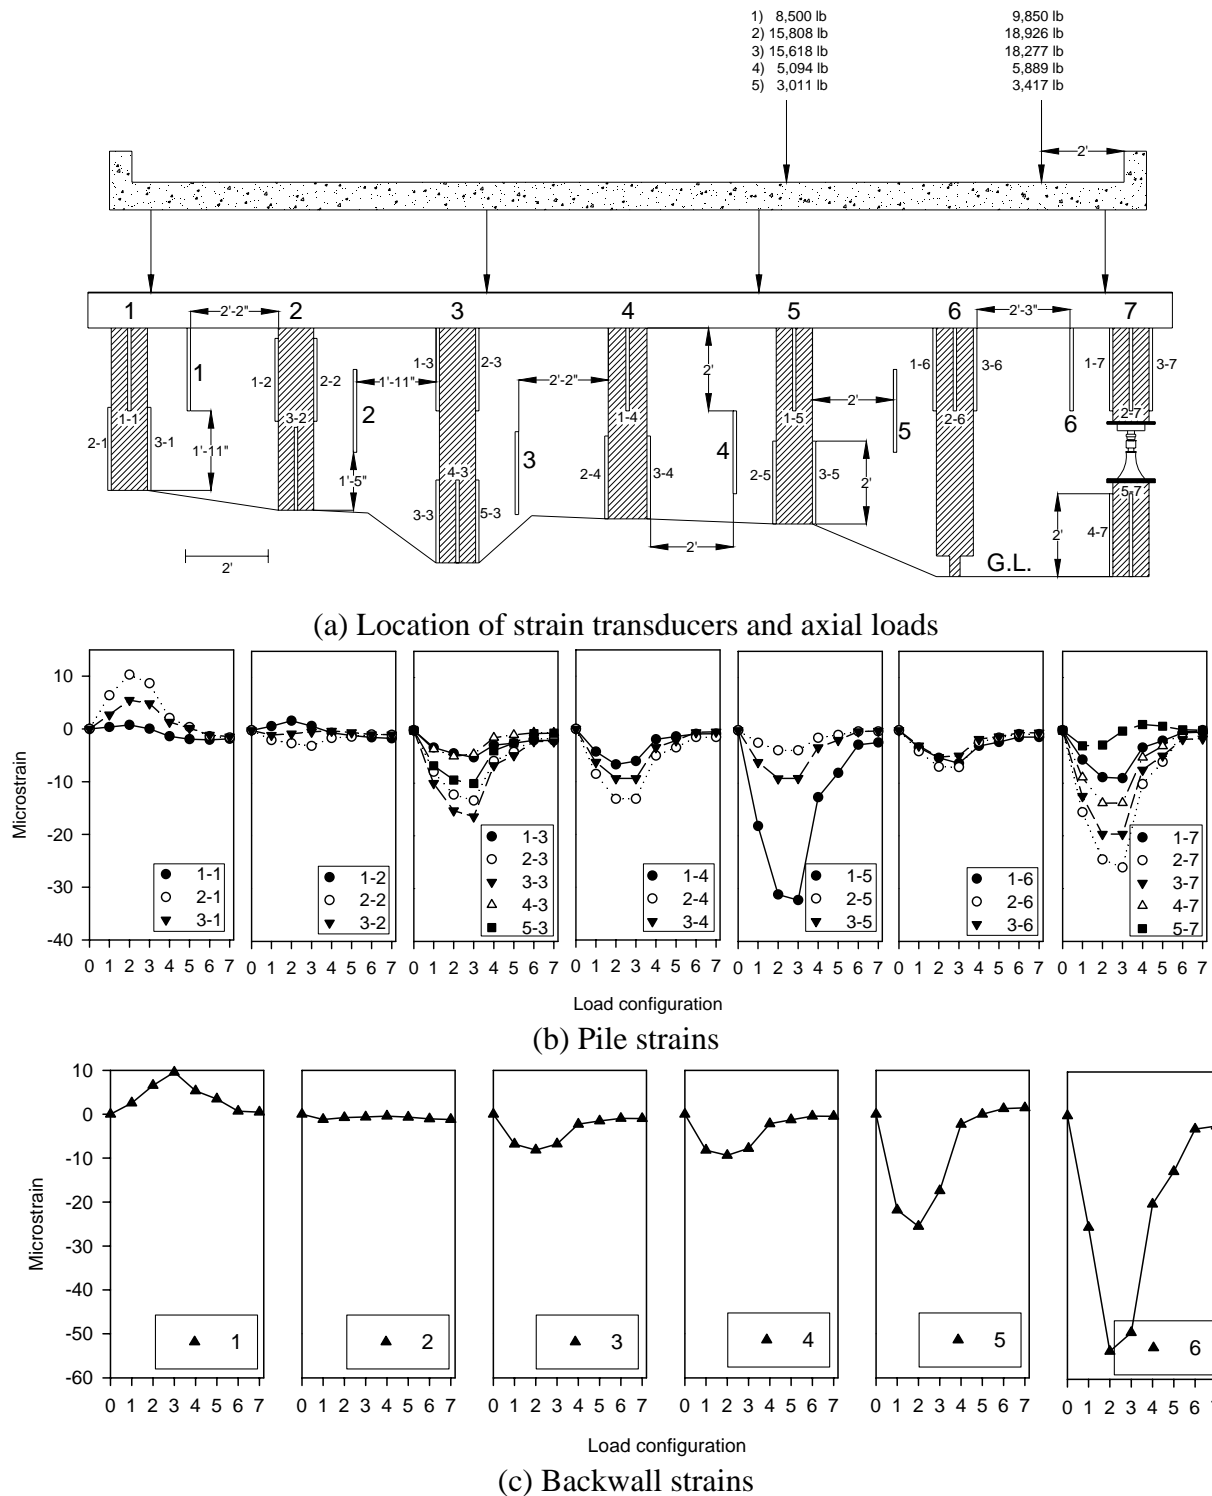
Figure 12.30. Static load test at the south edge with pile No. 7 jacked (Bridge No. 029070 – Humboldt County)

The abutment was next loaded at the south edge (See Figure 12.30). Compared to the nondestructive load test conducted at the south end, the strains in pile no. 7 decreased by about 45%, whereas the strains in pile no. 5 increased by approximately 30%. It is possible that jacking pile no. 7 resulted in a relatively weaker pile compared to its initial condition, and as a result, the load was transferred to the adjacent pile no. 5. No load was transferred to pile no. 6 since the pile was deteriorated. There were no significant changes in strains measured at other piles. The backwall strains at the south edge of the abutment (pile nos. 4 through 7) increased by about 40%. Loading the abutment at the south edge resulted in an increase of the percent load carried by pile no. 7 to about 35% of the total applied axial load.

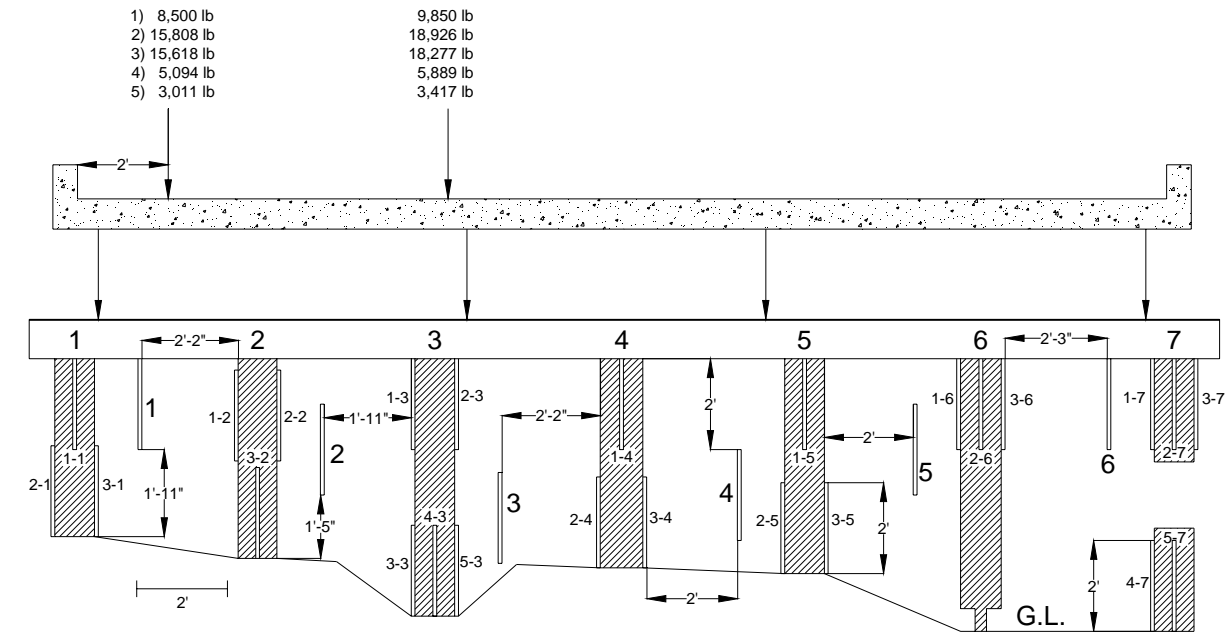
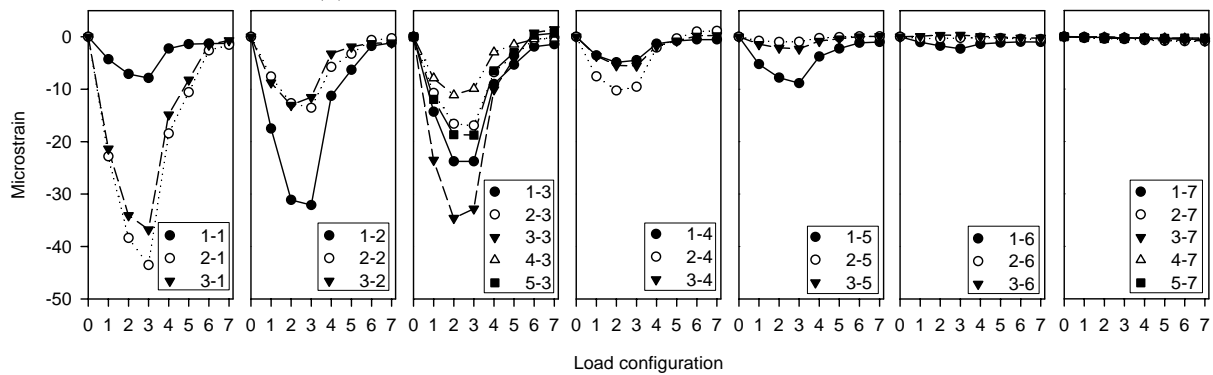
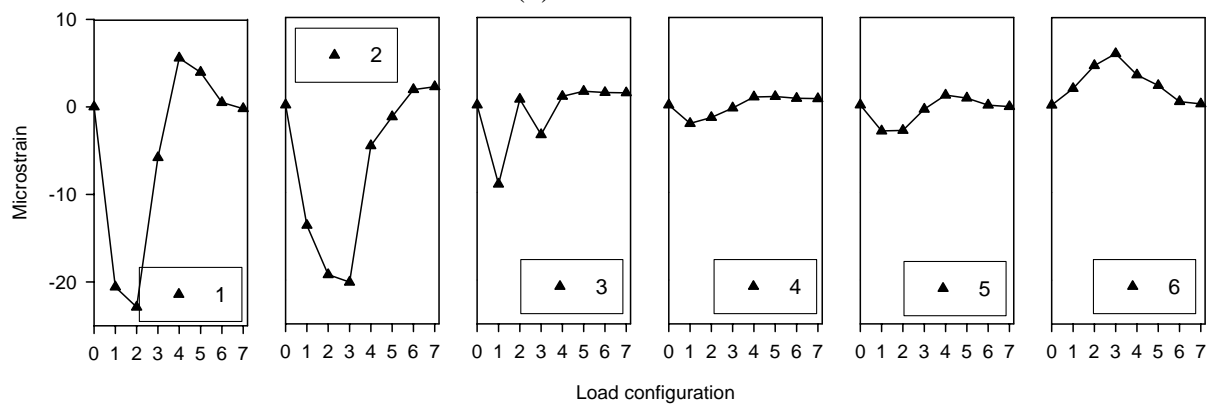
Figure 12.31. Static load test at the north edge with pile No. 7 removed (Bridge No. 029070 – Humboldt County)

The first load test was completed with the loading at the north edge of the bridge. The location of loads, pile strain measurements, and backwall strains are shown in Figure 12.31. The pile strains were approximately equal to those measured during the nondestructive load test, which was carried out at the north edge of the east abutment (Refer to Figure 12.26). This is because pile no. 7 did not endure any load when the abutment was loaded at the opposite edge. The backwall strains were also similar to the nondestructive test except those measured between pile nos. 6 and 7, which increased by about 60%. It can therefore be concluded that an exterior pile will not have a significant influence if the live load is concentrated on the edge opposite to the location of the deteriorated pile in the bridge.

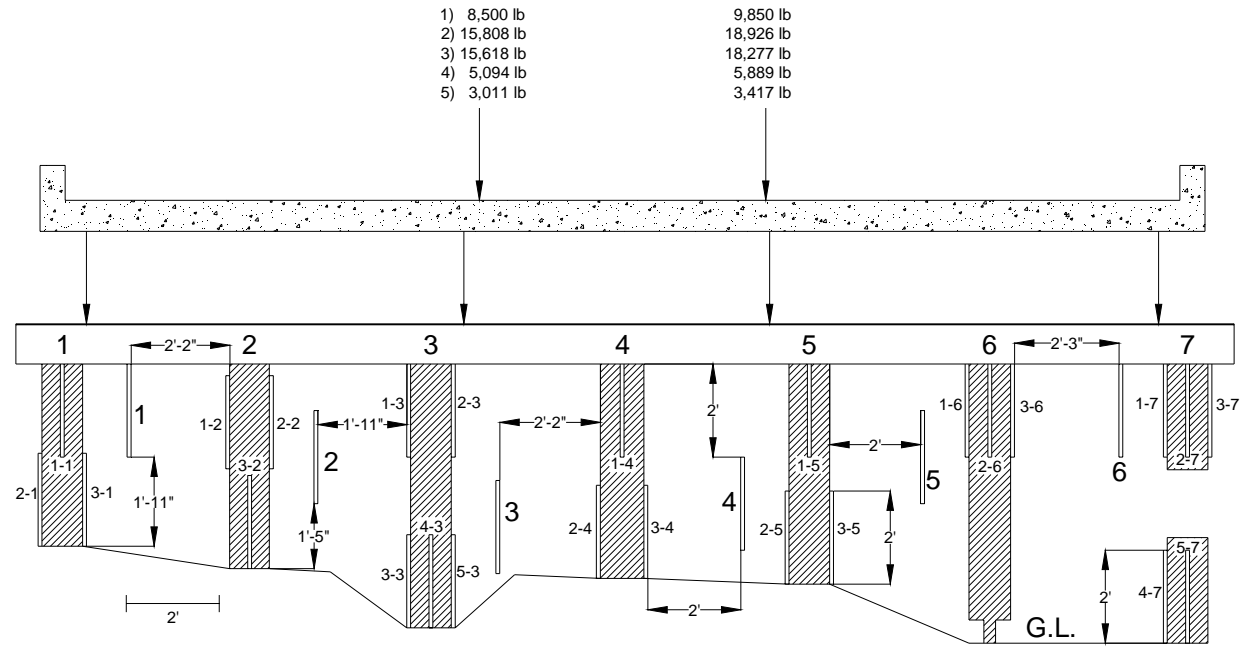
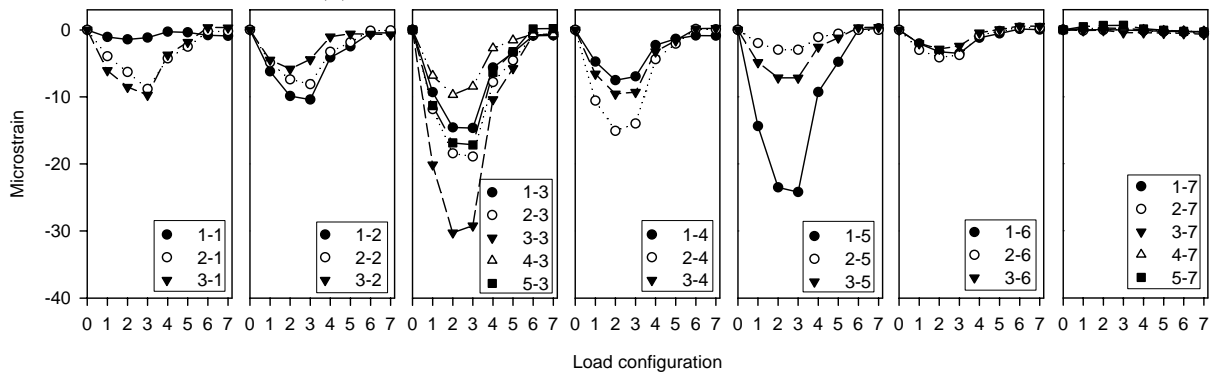
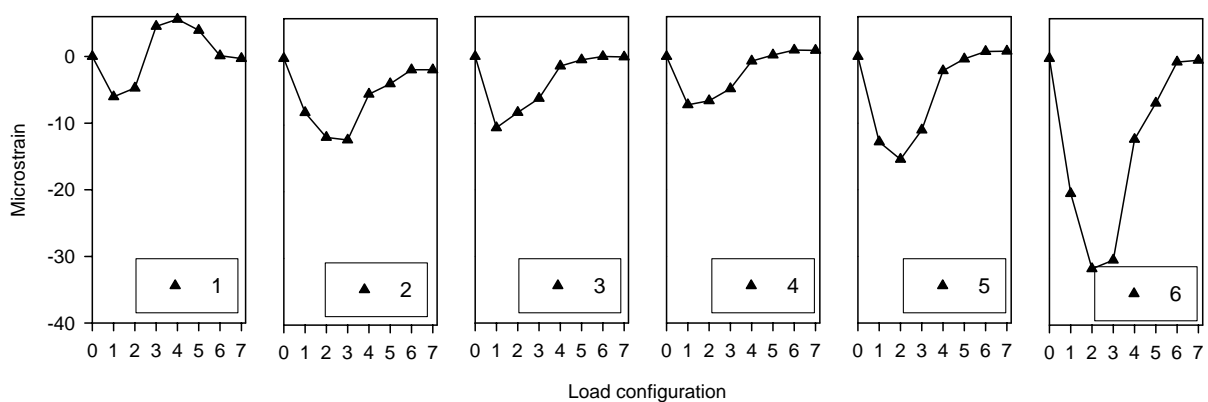
Figure 12.32. Static load test at the centerline with pile No. 7 removed (Bridge No. 029070 – Humboldt County)

The east abutment was then loaded at the centerline of the bridge deck. The location of loads, pile strain measurements, and backwall strains are presented in Figure 12.32. The results reveal a 25% increase in strain in pile no. 5 and about a 3% increase in the measured strains in pile nos. 3 and 4 compared to the nondestructive test at the same location. Most of the load carried by pile no. 7 was transferred to the next adjacent sound pile. The backwall strains also increased in the areas between pile Nos. 4 and 5, 5 and 6, and 6 and 7. About 63% strain was measured between pile nos. 6 and 7. Due to the partial bearing of the pile cap on the backwall, and due to the removal of pile no. 7, the backwall resisted a higher load as evidenced by the increase in negative strain at this location.

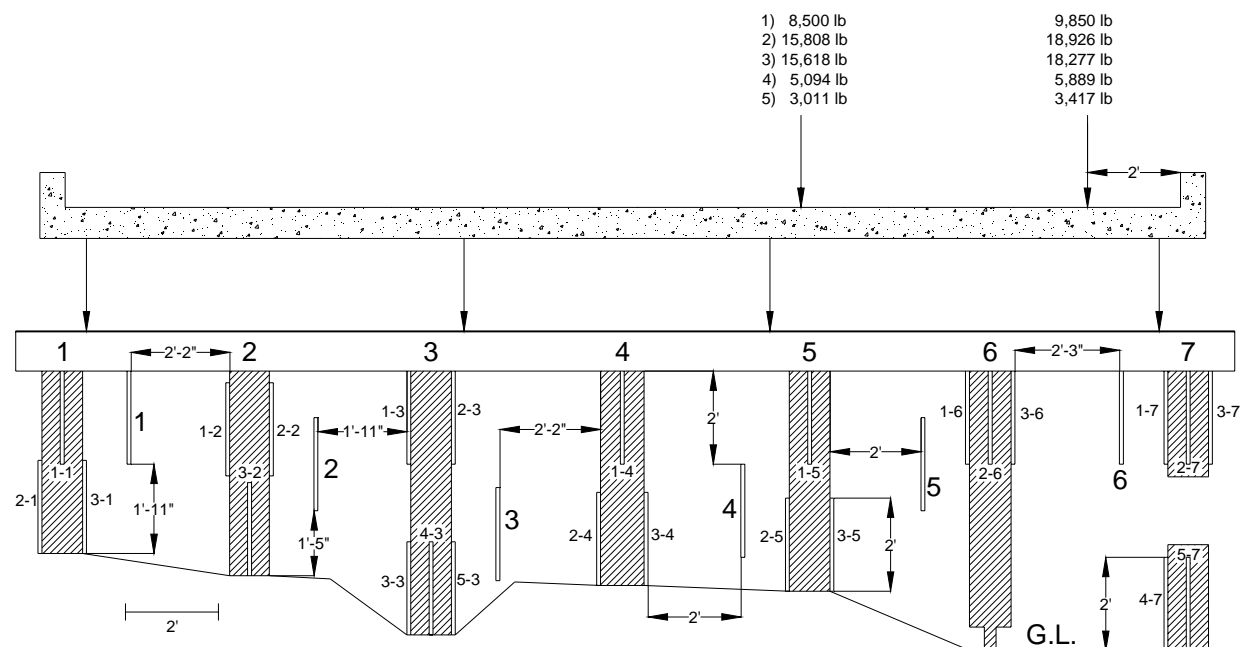
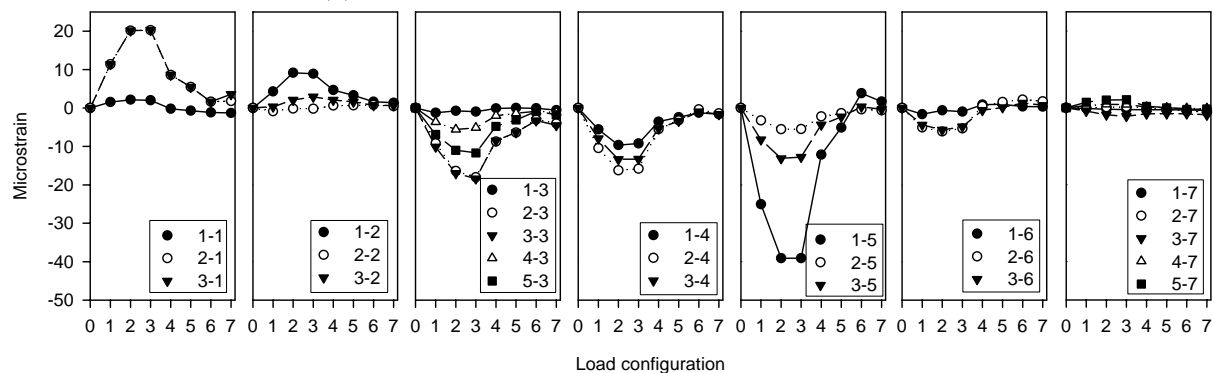
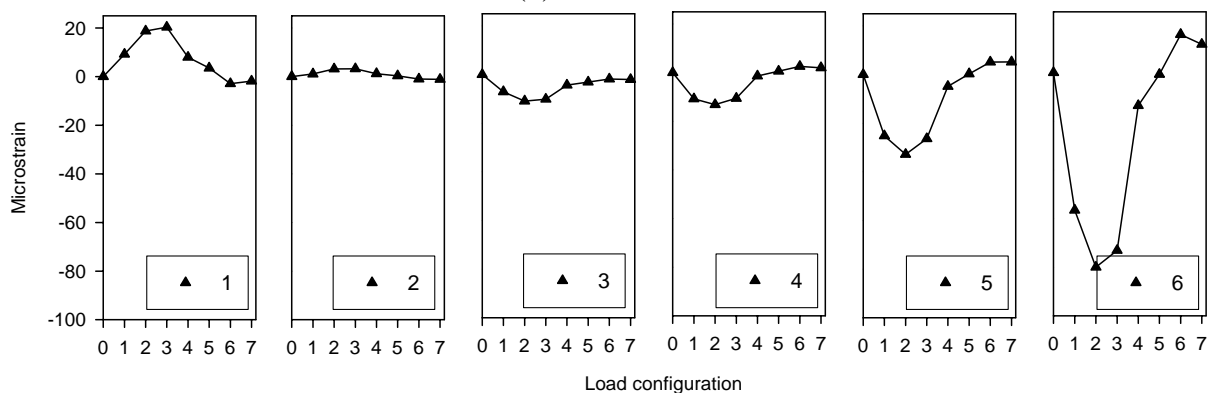
Figure 12.33. Static load test at the south edge with pile No. 7 removed (Bridge No. 029070 – Humboldt County)

The third test was conducted with the load applied at the south abutment directly above the removed pile. The location of loads, pile strain measurements, and backwall strains are shown in Figure 12.33. The strains measured in pile no. 5 increased by approximately 60%. Strains measured in pile nos. 3 and 4 increased by 20 and 45%, respectively. The results demonstrate that most of the load carried by pile no. 7 was being resisted by pile No. 5. The results also show that pile bending at the north edge increased. This was evidenced by the increase in positive strains in pile nos. 1 and 2. In pile no. 1, the strain increased from +9 microstrains, measured during the nondestructive test in this location, to +20 microstrains in load configuration 3, whereas in pile no. 2, the strain increased from 0 microstrains to +9 microstrains. This was also observed in the backwall strains between pile No. 1 and 2, which increased from +7 microstrains to +21 microstrains. The backwall strains under the applied load (i.e. between pile nos. 6 and 7) increased from -38 microstrains, which was measured during the nondestructive test, to -80 microstrains since more load was being transferred and resisted by the south edge of the backwall. The strains measured between pile nos. 4 and 5, and 5 and 6 also increased by almost 100%.

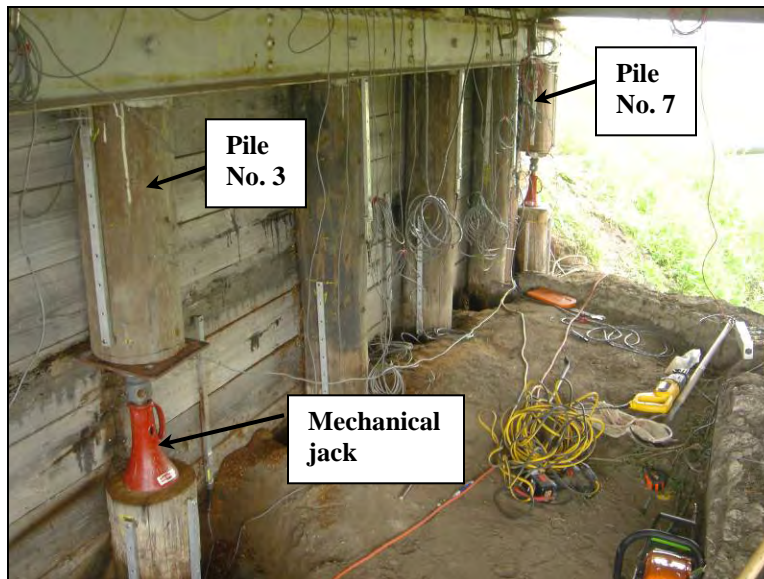
Figure 12.34. Pile Nos. 3 and 7 jacked (Bridge No. 029070 Humboldt County – July 12 2006)

In this destructive test, a section was removed from pile no. 3 after which both pile nos. 3 and 7 were jacked to their initial measured strain values (See Figure 12.34). A load cell was placed above each mechanical jack to measure the load carried by each pile due to live load. Three load tests were conducted with the load being applied at the north, centerline, and south edges.

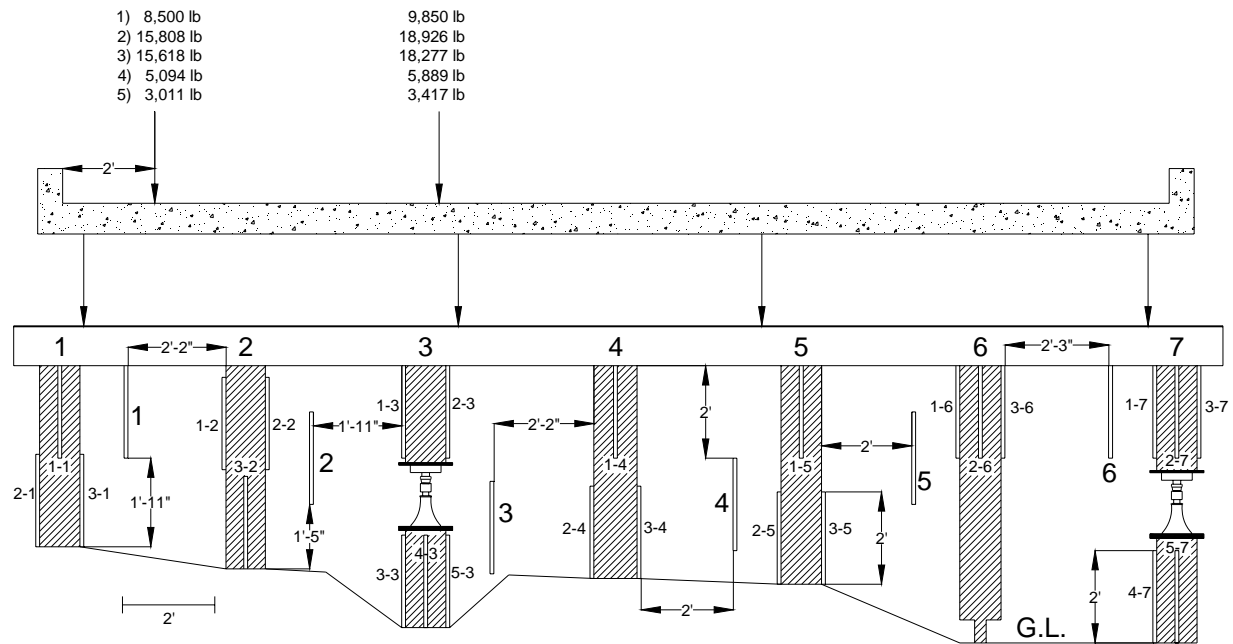
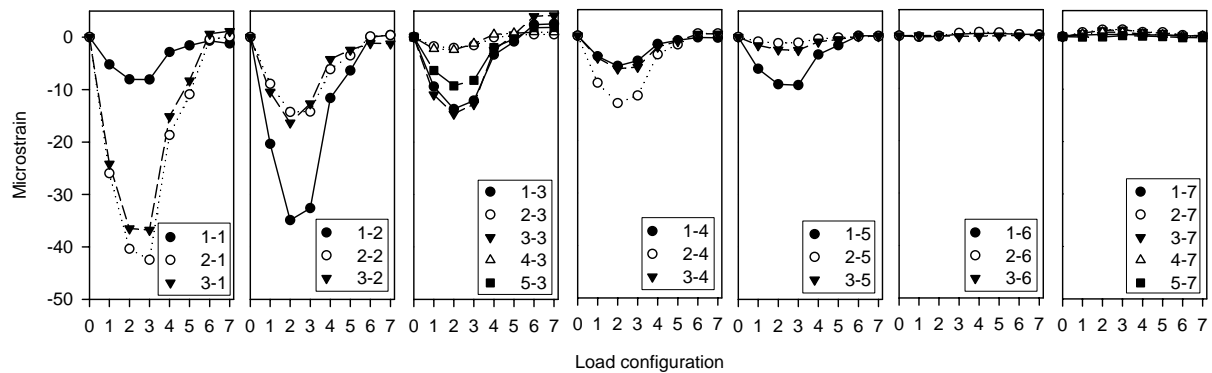
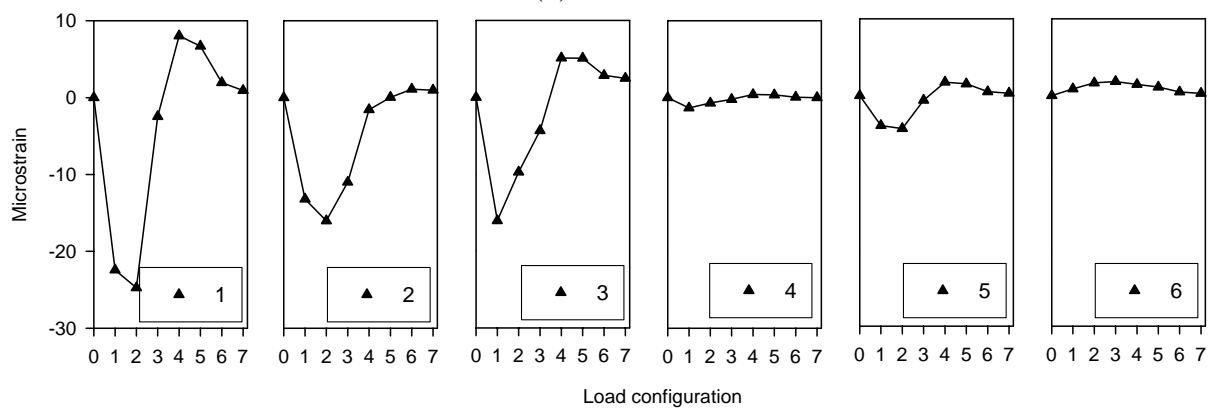
Figure 12.35. Static load test at the north edge with pile Nos. 7 and 3 jacked (Bridge No. 029070 – Humboldt County)

The east abutment was first loaded at the north edge of the bridge. The location of the loads, which were offset 2 ft from the curb, the pile strain measurements, and the backwall strains are presented in Figure 12.35. The results illustrate that the strains in pile no. 3 decreased by about 45% compared to those measured during the nondestructive test at this location. As a result, the strains in the adjacent pile nos. 2 and 4 increased by about 39 and 6%, respectively. The results show that the load carried by pile no. 3 was about 10% of the total load when the abutment was loaded at the north edge.

No significant change was observed in the backwall strains compared to the strains that occurred in the nondestructive test except in the strain between pile nos. 3 and 4. The strains measured in this location increased by approximately 60%. A possible explanation for this increase is that the mechanical jack did not fully restore the timber pile to its initial condition as evidenced by the strain reduction in the pile compared to the nondestructive test strains; therefore, the backwall at this location was resisting more axial load due to the partial bearing of the pile cap on the backwall resulting in higher deflections.
